[Docket No. 2002-SW-38-AD; Amendment 39-12935; AD 2002-22-10]

Airworthiness Directives; Bell Helicopter Textron Canada Limited Model 407 Helicopters

2002-22-10 Bell Helicopter Textron Canada Limited: Amendment 39-12935. Docket No. 2002-SW-38-AD. Supersedes AD 2000-20-18, Amendment 39-11930, Docket No. 2000-SW-24-AD.

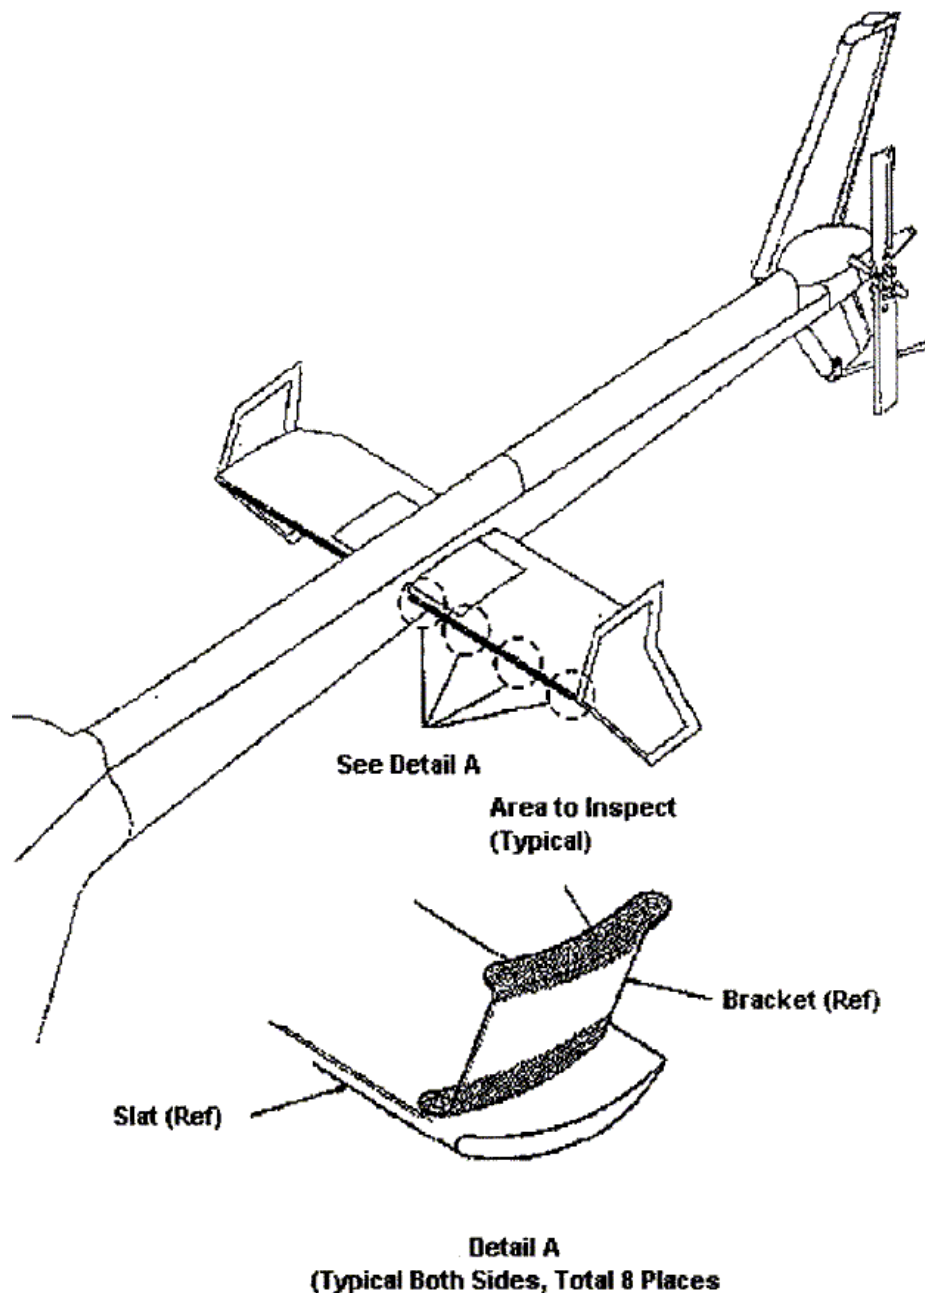
Figure 1. Pre-Flight check of brackets, horizontal stabilizer slats.

Since issuing that AD and since installing the newly designed slat assembly, part number (P/N) 407-023-001-101 on affected helicopters, two additional cracked slat brackets have been reported. These occurrences are attributed to a design flaw and improper installation of the slat assembly.

(1) Within 10 hours time-in-service (TIS) and thereafter before the first flight of each day, check each slat for a crack at the radius of each bracket, part numbers (P/N) 206-023-119-109, -110 or 407-023-801-127, -128, or 407-023-001-119, -120, or -121, as shown in Figure 1 of this AD:

(3) If a crack is found, before further flight, replace slat assembly, P/N 407-023-002-117 or 407-023-001-101, with an airworthy, segmented slat assembly, P/N 407-023-001-103.

(4) Replacing slat assembly, P/N 407-023-002-117 and 407-023-001-101, with an airworthy, segmented slat assembly, P/N 407-023-001-103, is terminating action for the check required by paragraph (a)(1) of this AD.
